**Flood Control Project Maintenance  
Levee Inspections**

**Fall 2016 Levee Maintenance Deficiency Summary Report**

**Solano County Public Works Mellin Levee**

**Levee Inspection Report By Mile - Fall 2016**

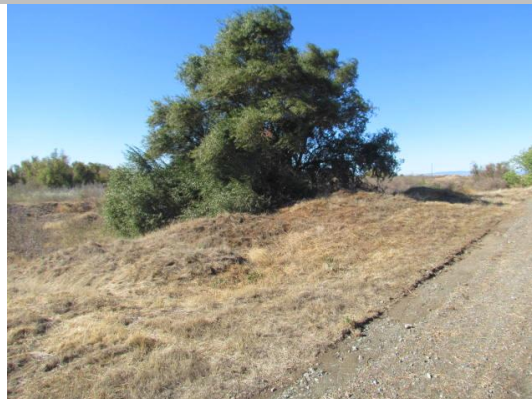
Photo 2 of 2 : FA\_2016\_NA0012\_258\_12\_20161007\_00009.jpg

LM Start	0.59	Rating **	U	Issue No.	12 (cont)	
LM End	0.59	Issue Type +	Ma	Location *	LS	
Category	Earthen Levee			GPS Latitude/Longitude		
				Start		End
Item	Trim / Thin Trees			38.180062 °		38.180062 °
				-121.681993 °		-121.681993 °
DWR ID	DWR_NA0012_01_s _ 2015_12					
Comment Code						
T1 : Trim trees to at least five feet above ground level.						
Inspector Comment						
Untrimmed tree on landward shoulder and slope.

Looking at untrimmed tree on landward slope fall 2015.
